Arboricultural Report
Trees at Proposed Development at
Ballinderry Road
Mullingar
Co Westmeath

March 2022

The Tree File Ltd
Consulting Arborists
Ashgrove House
26 Foxrock Court
Dublin 18
D18 R2K1
086-3819011

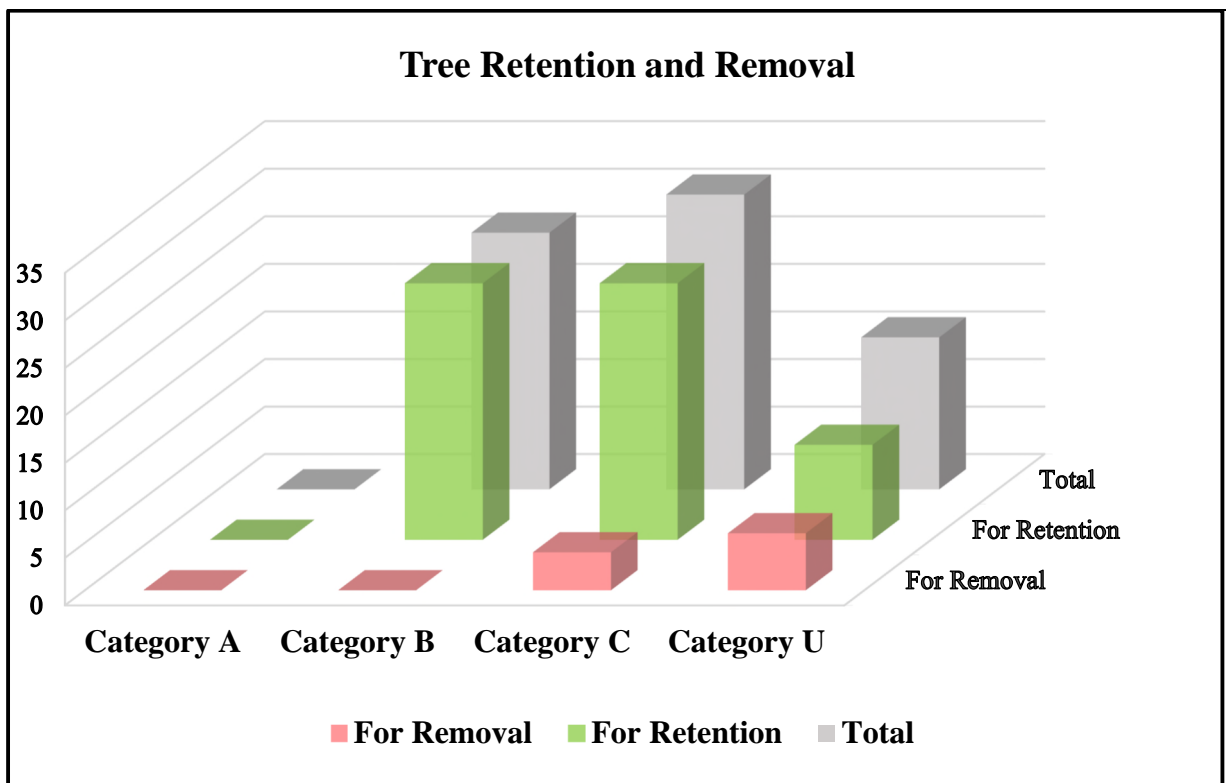
Fig 5 Graphic Representation of Tree Loss/Retention Scenario

- 11.4 Of the site’s category “good” quality “B” trees, the development works appears to require the removal of nos. 6, 9, 16, 28, 29, 38, 46, 52 and 53.

11.5 Of the site’s category “poor” quality “C” trees, the development works appears to require the removal of nos. 4, 5, 7, 8, 10, 11, 12, 13, 14, 15, 17, 18, 19, 20, 21, 22, 23, 24, 25, 26, 30, 31, 32, 33, 36, 37, 47, 48, 49, 50, 51, 54, 55, 56 and 57.
