Arboricultural Report
Trees at Proposed Development at
Ballinderry Road
Mullingar
Co Westmeath

March 2022

The Tree File Ltd
Consulting Arborists
Ashgrove House
26 Foxrock Court
Dublin 18
D18 R2K1
086-3819011

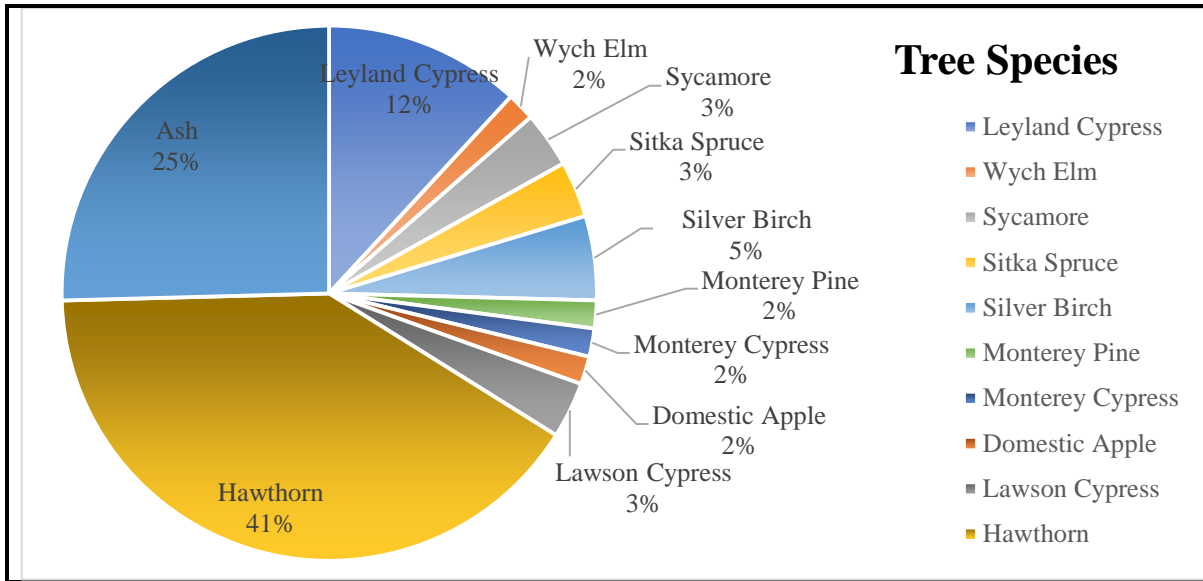
Fig 5

4.14 As can be seen from the graphs above, the species diversity (fig 5) illustrates the extent of garden planting, while the dominance of Ash and Hawthorn illustrates natural regeneration and a prior agricultural landscape. The review of tree categories and conditions appear to correlate with category “C” and “Fair” and Fair-poor” trees dominating. This apparently reduced quality is equally reflected in the dominance of medium-term sustainability and limited long-term sustainability. These issues should be regarded in respect of the dominance of mature trees that suggests a need for additional planting of young trees to improve sustainability over time.
